**Flood Control Project Maintenance
Levee Inspections**

Fall 2018 Levee Maintenance Deficiency Summary Report

Sacramento River Basin

**Flood Control Project Maintenance
Levee Inspections****LMA District Cover Sheet****Fall 2018 Levee Inspection Results****Sutter Maintenance Yard Maintenance Area 0001**

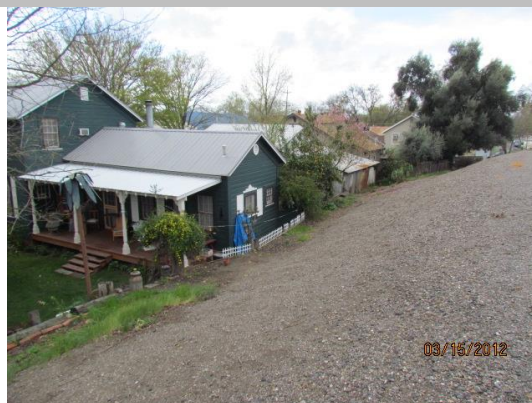
Photo 1 of 1 : FA_2018_MA0001_297_2_20180905_00001.jpg

LM Start	0.04	Rating **	U	Issue No.	2
LM End	0.23	Issue Type +	En	Location *	LS
Category	Earthen Levee			GPS Latitude/Longitude	
				Start	End
Item	Encroachments			39.213988 °	39.215198 °
				-122.001537 °	-122.004775 °
DWR ID	DWR_MA0001_01_s_2012_2				
Comment Code					
BU : Building					
Inspector Comment

View of the building along the landside toe.

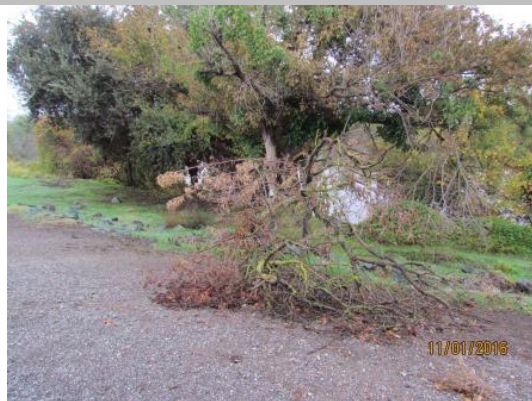
Photo 1 of 1 : FA_2018_MA0001_297_93_20180905_00026.jpg

LM Start	0.07	Rating **	M	Issue No.	93
LM End	0.07	Issue Type +	Ma	Location *	WS
Category	Earthen Levee			GPS Latitude/Longitude	
				Start	End
Item	Encroachments			39.214162 °	39.214162 °
				-122.002158 °	-122.002158 °
DWR ID	DWR_MA0001_01_f_2016_93				
Comment Code					
TR : Tree or limb					
Inspector Comment

View of a tree limb along the waterside slope.

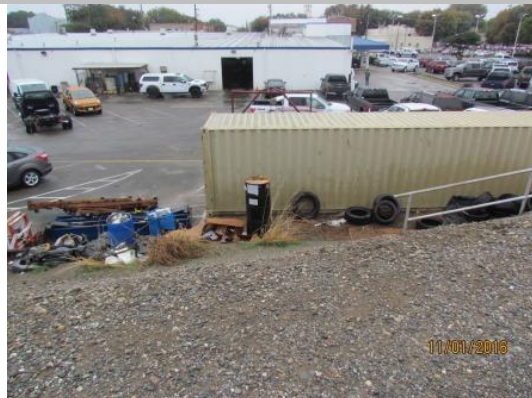
Photo 1 of 1 : FA_2018_MA0001_297_99_20180905_00029.jpg

LM Start	0.42	Rating **	M	Issue No.	99
LM End	0.42	Issue Type +	En	Location *	LS
Category	Earthen Levee			GPS Latitude/Longitude	
				Start	End
Item	Encroachments			39.215863 °	39.215863 °
				-122.008015 °	-122.008015 °
DWR ID	DWR_MA0001_01_f_2016_99				
Comment Code					
EQ : Equipment					
Inspector Comment					
Move the equipment and container at least 10' away from the landside toe.

View of the equipment and shipping container along the landside toe.

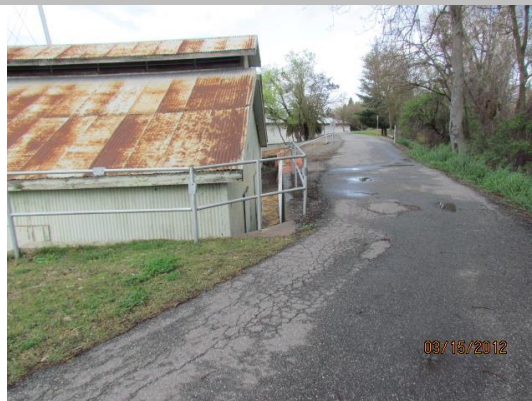
Photo 1 of 1 : FA_2018_MA0001_297_7_20180905_00005.jpg

LM Start	0.67	Rating **	U	Issue No.	7
LM End	0.70	Issue Type +	En	Location *	LS
Category	Earthen Levee			GPS Latitude/Longitude	
				Start	End
Item	Encroachments			39.216533 °	39.216680 °
				-122.012512 °	-122.012907 °
DWR ID	DWR_MA0001_01_s_2012_7				
Comment Code					
BU : Building					
Inspector Comment

View of the buildings along the landside toe.

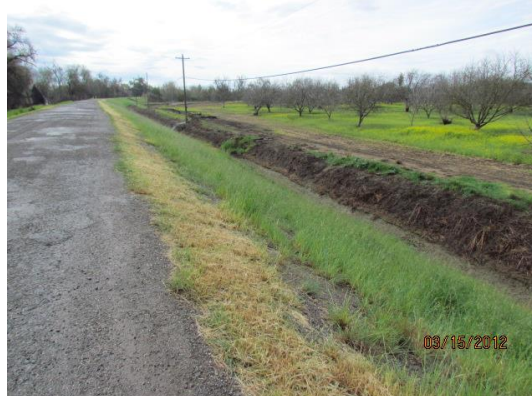
Photo 1 of 1 : FA_2018_MA0001_297_6_20180905_00004.jpg

LM Start	1.20	Rating **	U	Issue No.	6
LM End	1.34	Issue Type +	En	Location *	LS
Category	Earthen Levee			GPS Latitude/Longitude	
				Start	End
Item	Encroachments			39.222119 °	39.224063 °
				-122.015747 °	-122.016080 °
DWR ID	DWR_MA0001_01_s_2012_6				
Comment Code					
DT : Ditch					
Inspector Comment

View of an ag ditch along the landside toe.

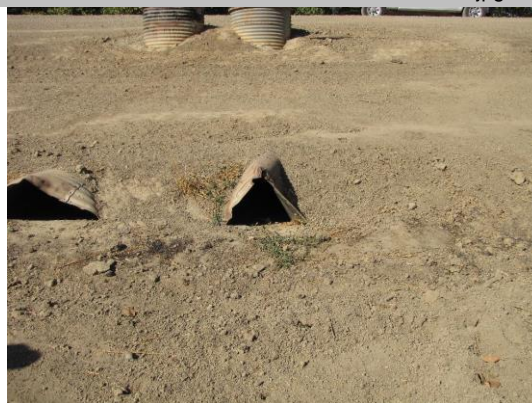
Photo 3 of 3 : UCIP_FA_2018_51853_70073.jpg

FS_ID:51853
DS_ID:17565
EP_NO: 9487
Repair Type: Non-Urgent
Crossing Status: Found
UCIP Comments: 5/3/2017 Ws end still partially plugged. (DWR Sutter Yard- A Freitag)10/24/2016 Ws pipe end still plugged.(DWR Sutter Yard- A Freitag)4/25/2016 WS pipe end still plugged with soil. rest of pipe appears in good condition.4/20/2015 WS pipe end plugged about 50% by soil.6/18/2014 Same as last inspection.12/17/2013 Same as last inspection.7/18/2013 WS pipe end has been reformed but is still partially blocked with dirt and debris.10/18/2012 WS-remove dirt and debris in riser. Outlet deformed and blocked over 50%. Burrow activity near outlet on waterward slope. Debris around concrete section on landward side. This crossing was listed in the USACE Periodic Inspections as ID# USACE_CESPK_MA1C_2010_p_0116 for crossing outlet deformed and clogged with dirt.
FIELD_STRUCT_DESC: 2 of 2: 36-inch corrugated metal drainage pipe through the levee, approximately 12-15 feet below the crown. Slide gates in corrugated metal pipe (CMP) riser on the waterside (WS) slope. Pipe daylights on the landside (LS). (36-inch pipe [HLM 1.97] authorized under Automatic Board Order (ABO) issued as Permit No. 9487, 1974 - Jimeno Rancho) [Additional Reference(s): DWR Levee Log, 1992. USACE Sacramento O&M Manual 137, August 1955, (Station 103+18)].

CMP pipe outlet deformed with over 50 percent blockage.

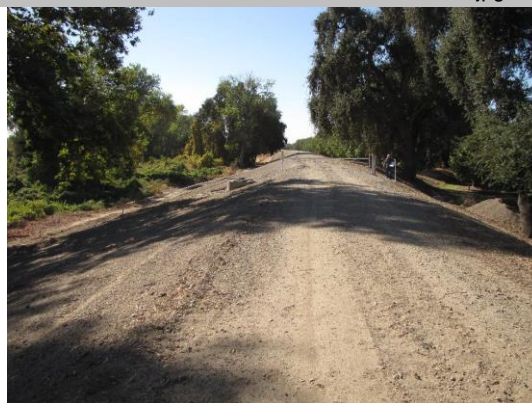
Photo 1 of 3 : UCIP_FA_2018_51854_70078.jpg

Comment Code						
Inspector Comment						
FS_ID:51854 DS_ID:16429 EP_NO: 9472 Repair Type: Non-Urgent Crossing Status: Found UCIP Comments: 5/3/2017 LS inlet partially plugged with soil. Some debris still present inside riser. (DWR Sutter Yard-AFreitag)10/24/2016 Debris still inside of riser.(DWR Sutter Yard-AFreitag)4/25/2016 Pipe still inside of riser and LS end plugged about 50% by soil.4/20/2015 Same as last inspection.6/18/2014 Same as last inspection.12/17/2013 Same as last inspection.7/18/2013 Same as last inspection.10/18/12 Remove debris from riser. Landward inlet is blocked by over 50%. This crossing was listed in the USACE Periodic Inspections as ID# USACE_CESPK_MA1C_2010_p_0128 for sediment build up at inlet (landward side) and debris inside riser. FIELD_STRUCT_DESC: 54-inch corrugated metal drainage pipe through the levee, approximately 12-15 feet below the crown. Slide gate in corrugated metal pipe (CMP) riser on the waterside (WS) slope. 48-inch CMP at landside (LS) slope. This crossing crosses the levee at an angle. (54-inch pipe [HLM 2.29] authorized under Automatic Board Order (ABO) issued as Permit No. 9472, 1974 - Ballard)) [Additional Reference(s): DWR Levee Log, 1992. USACE Sacramento O&M Manual 137, August 1955, (Station 120+00)]. FS Date: 5/19/2017 1:23:34 PM

View of levee crown looking downstream at crossing. CMP riser located on WS shoulder.

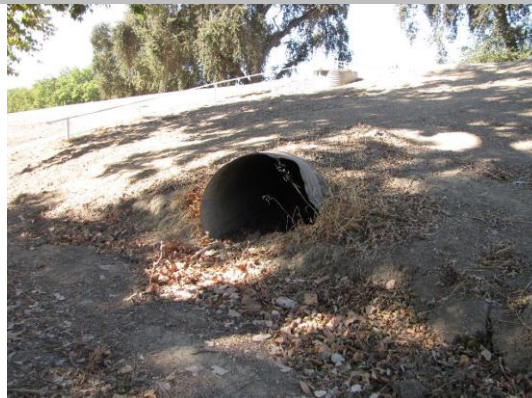
Photo 3 of 3 : UCIP_FA_2018_51854_70077.jpg

Comment Code						
Inspector Comment						
FS_ID:51854 DS_ID:16429 EP_NO: 9472 Repair Type: Non-Urgent Crossing Status: Found UCIP Comments: 5/3/2017 LS inlet partially plugged with soil. Some debris still present inside riser. (DWR Sutter Yard-AFreitag)10/24/2016 Debris still inside of riser.(DWR Sutter Yard-AFreitag)4/25/2016 Pipe still inside of riser and LS end plugged about 50% by soil.4/20/2015 Same as last inspection.6/18/2014 Same as last inspection.12/17/2013 Same as last inspection.7/18/2013 Same as last inspection.10/18/12 Remove debris from riser. Landward inlet is blocked by over 50%. This crossing was listed in the USACE Periodic Inspections as ID# USACE_CESPK_MA1C_2010_p_0128 for sediment build up at inlet (landward side) and debris inside riser. FIELD_STRUCT_DESC: 54-inch corrugated metal drainage pipe through the levee, approximately 12-15 feet below the crown. Slide gate in corrugated metal pipe (CMP) riser on the waterside (WS) slope. 48-inch CMP at landside (LS) slope. This crossing crosses the levee at an angle. (54-inch pipe [HLM 2.29] authorized under Automatic Board Order (ABO) issued as Permit No. 9472, 1974 - Ballard)) [Additional Reference(s): DWR Levee Log, 1992. USACE Sacramento O&M Manual 137, August 1955, (Station 120+00)]. FS Date: 5/19/2017 1:23:34 PM

View of outlet located at WS toe.

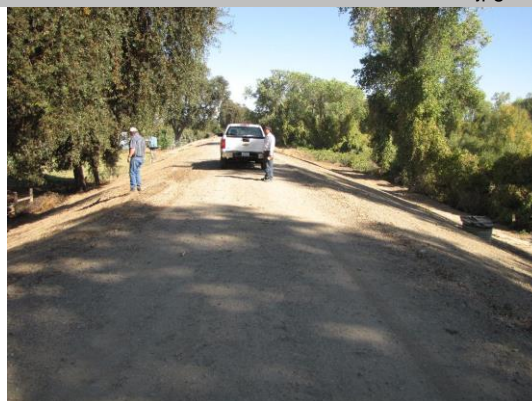
Photo 1 of 3 : UCIP_FA_2018_51855_70085.jpg

Comment Code						
Inspector Comment						
FS_ID:51855 DS_ID:16428 EP_NO: 9467 Repair Type: Non-Urgent Crossing Status: Found UCIP Comments: 5/3/2017 Abandoned- needs to be done so properly. (DWR Sutter Yard- A Freitag)10/24/2016 Abandoned.(DWR Sutter Yard- A Freitag)4/25/2016 Abandoned crossing. Unable to locate any WS and LS pipe ends.4/20/2015 Same as last inspection.6/18/2014 Same as last inspection.12/17/2013 Same as last inspection.7/18/2013 Same as last inspection.10/18/2012 Only riser visible. Debris and sediment blocking gate. Gate inside riser is buried and non-functional. If crossing is abandoned, owner needs to properly abandon. This crossing was listed in the USACE Periodic Inspections as ID# USACE_CESPK_MA1C_2010_p_0132 no culvert through the levee is visible here. FIELD_STRUCT_DESC: *ABANDONED* 24-inch corrugated metal drainage pipe through the levee, approximately 12-15 feet below the crown. Slide gate in CM pipe riser on the waterside (WS) slope. No signs of inlet visible on the landside (LS). (24-inch pipe [HLM 2.31] authorized under Automatic Board Order (ABO) issued as Permit No. 9467, 1974 - Lovell E. Spurgeon) [Additional Reference(s): DWR Levee Log, 1992. USACE Sacramento O&M Manual 137, August 1955, (Station 120+60)]. FS Date: 5/19/2017 1:48:04 PM

Overview of levee crown looking upstream at crossing.

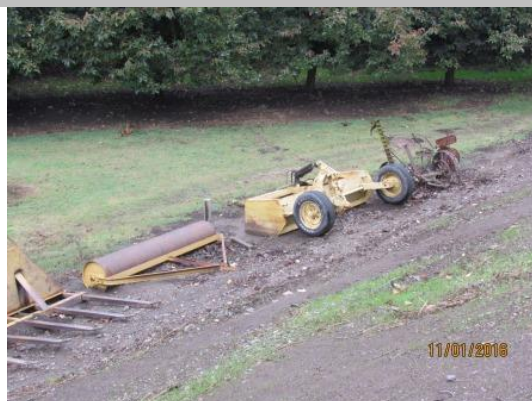
Photo 1 of 1 : FA_2018_MA0001_297_107_20180905_00031.jpg

LM Start	2.36	Rating **	M	Issue No.	107
LM End	2.36	Issue Type +	En	Location *	LS
Category	Earthen Levee			GPS Latitude/Longitude	
				Start	End
Item	Encroachments			39.237628 °	39.237628 °
				-122.011967 °	-122.011967 °
DWR ID	DWR_MA0001_01_f_2016_107				
Comment Code					
EQ : Equipment					
Inspector Comment

View of the ag equipment along the landside toe.

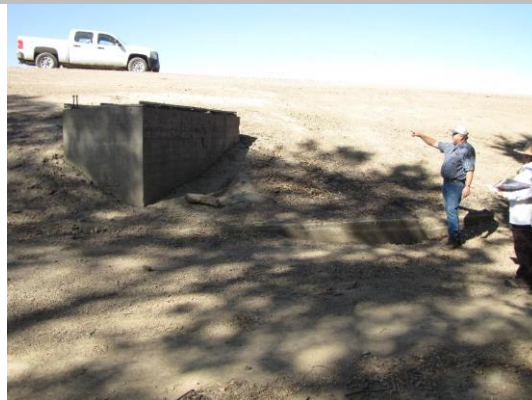
Photo 2 of 3 : UCIP_FA_2018_51856_70094.jpg

Comment Code						
Inspector Comment						
FS_ID:51856 DS_ID:16416 EP_NO: 9474 Repair Type: Non-Urgent Crossing Status: Found UCIP Comments: 5/3/2017 Appears abandoned- WS vault full of soil. Needs to be abandoned properly. (DWR Sutter Yard- AFreitag)10/24/2016 Appears to be abandoned. WS vault full of soil to help prevent water from flowing through during high water season.(DWR Sutter Yard- AFreitag)4/25/2016 Concrete box was filled with dirt to help prevent water from through during high water times.4/20/2015 Positive closure device is missing and water cannot be prevented from flowing through pipe during high water. 6/18/2014 Same as last inspection.12/17/2013 Same as last inspection.7/18/2013 Same as last inspection.10/18/12 During high water flow goes through levee. Missing positive closure device on waterward side. This structure appears abandoned-slide gates have been removed. Crossing needs to be properly abandoned. This crossing was listed in the USACE Periodic Inspection as ID# USACE_CESPK_MA1C_2010_p_0169 for concrete box partially filled with dirt. FIELD_STRUCT_DESC: 1 of 2: 60-inch reinforced concrete irrigation pipe through the levee, approximately 12-15 feet below the crown. This crossing penetrates the levee at an angle. Slide gates in concrete well at the waterside (WS) toe. Slide gates missing. (Automatic Board Order (ABO) issued as Permit No. 9774, 1974 - George R. Zumwalt) O&M manual description is for two 5-foot by 5-foot concrete culverts with two hand-operated slide gates. Culvert constructed with wing walls and gates. [Additional Reference(s): DWR Levee Log, 1992. USACE Sacramento O&M Manual 137, August 1955, (Station 150+06)]. FS Date: 5/19/2017 1:48:47 PM

View of concrete distribution box and headwall located on WS.

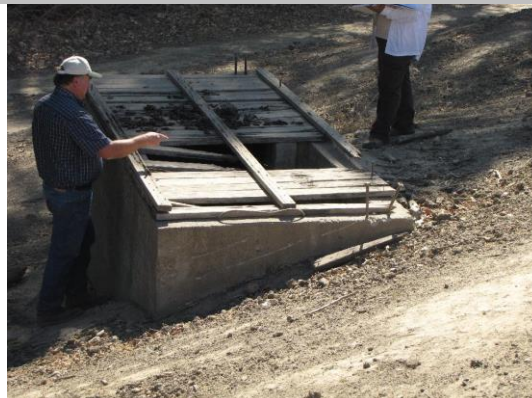
Photo 3 of 3 : UCIP_FA_2018_51856_70090.jpg

FS_ID:51856
DS_ID:16416
EP_NO: 9474
Repair Type: Non-Urgent
Crossing Status: Found
UCIP Comments: 5/3/2017 Appears abandoned- WS vault full of soil. Needs to be abandoned properly. (DWR Sutter Yard- AFreitag)10/24/2016 Appears to be abandoned. WS vault full of soil to help prevent water from flowing through during high water season.(DWR Sutter Yard- AFreitag)4/25/2016 Concrete box was filled with dirt to help prevent water from through during high water times.4/20/2015 Positive closure device is missing and water cannot be prevented from flowing through pipe during high water. 6/18/2014 Same as last inspection.12/17/2013 Same as last inspection.7/18/2013 Same as last inspection.10/18/12 During high water flow goes through levee. Missing positive closure device on waterward side. This structure appears abandoned-slide gates have been removed. Crossing needs to be properly abandoned. This crossing was listed in the USACE Periodic Inspection as ID# USACE_CESPK_MA1C_2010_p_0169 for concrete box partially filled with dirt.

Concrete distribution box located on WS shoulder.

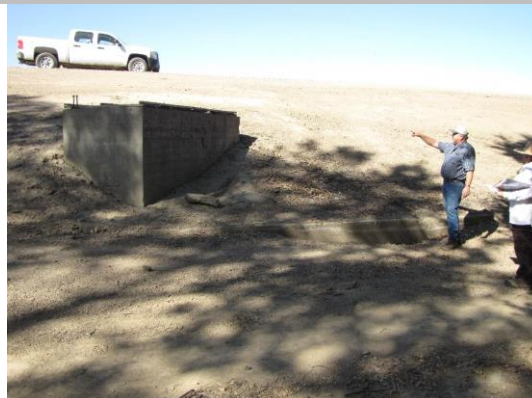
Photo 2 of 3 : UCIP_FA_2018_51857_70107.jpg

Comment Code						
Inspector Comment						
FS_ID:51857 DS_ID:17567 EP_NO: 9474 Repair Type: Non-Urgent Crossing Status: Found UCIP Comments: 5/3/2017 Appears abandoned- WS vault full of soil. Needs to be abandoned properly. (DWR Sutter Yard- AFreitag)10/24/2016 Appears to be abandoned. WS vault full of soil to help prevent water from flowing through during high water season.(DWR Sutter Yard- AFreitag)4/25/2016 Concrete box on WS was filled with soil to help prevent water form flowing through during times of high water.4/20/2015 Positive closure device is missing and water cannot be prevented from flowing through pipe during high water.6/18/2014 Same as last inspection.12/17/2013 Same as last inspection.7/18/2013 Same as last inspection.10/18/2015 During high water flow goes through levee. Missing positive closure device on waterward side. This structure appears abandoned-slide gates have been removed. Crossing needs to be properly abandoned. This crossing was listed in the USACE Periodic Inspection as ID# USACE_CESPK_MA1C_2010_p_0169 for concrete box partially filled with dirt. FIELD_STRUCT_DESC: 2 of 2: 60-inch reinforced concrete irrigation pipe through the levee, approximately 12-15 feet below the crown. Crossing goes through the levee at an angle. Slide gates in concrete well at the waterside (WS) toe. Slide gate missing. (Automatic Board Order (ABO) issued as Permit No. 9474, 1974 - George R. Zumwalt) O&M manual description is for two 5-foot by 5-foot concrete culverts with two hand operated slide gates. Culvert constructed with wing walls and gate well. [Additional Reference(s): DWR Levee Log, 1992. USACE Sacramento O&M Manual 137, August 1955, (Station 150+06)]. FS Date: 5/19/2017 1:49:51 PM

Concrete distribution box and headwall located on WS.

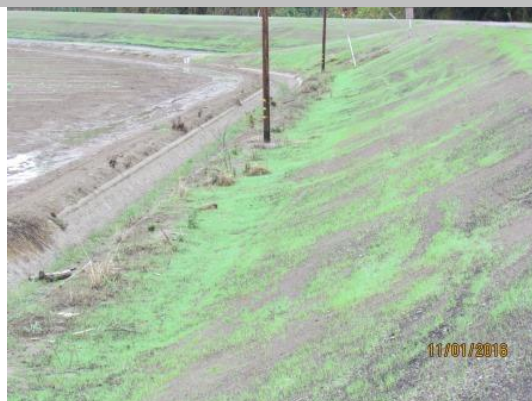
Photo 1 of 1 : FA_2018_MA0001_297_109_20180905_00032.jpg

LM Start	2.81	Rating **	U	Issue No.	109
LM End	2.92	Issue Type +	En	Location *	LS
Category	Earthen Levee			GPS Latitude/Longitude	
				Start	End
Item	Encroachments			39.243467 °	39.244902 °
				-122.008340 °	-122.007867 °
DWR ID	DWR_MA0001_01_f_2016_109				
Comment Code					
DT : Ditch					
Inspector Comment

View of a concrete lined ditch along the landside toe.

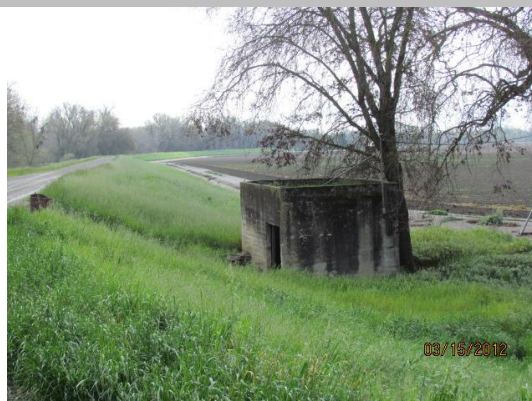
Photo 1 of 1 : FA_2018_MA0001_297_5_20180905_00003.jpg

LM Start	3.05	Rating **	U	Issue No.	5
LM End	3.46	Issue Type +	En	Location *	LS
Category	Earthen Levee			GPS Latitude/Longitude	
				Start	End
Item	Encroachments			39.246813 °	39.252748 °
				-122.008155 °	-122.008320 °
DWR ID	DWR_MA0001_01_s_2012_5				
Comment Code					
DT : Ditch					
Inspector Comment

View of the ag. ditch & concrete building along the landside toe.

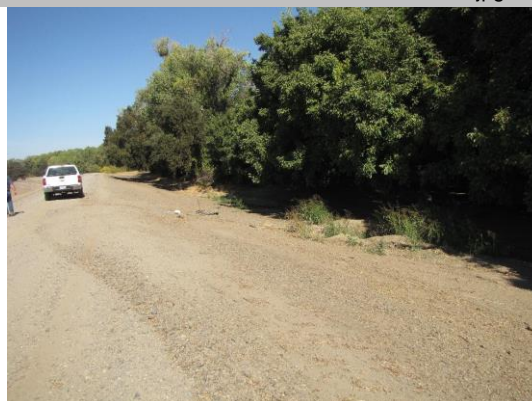
Photo 2 of 3 : UCIP_FA_2018_51859_70109.jpg

View of WS looking upstream.

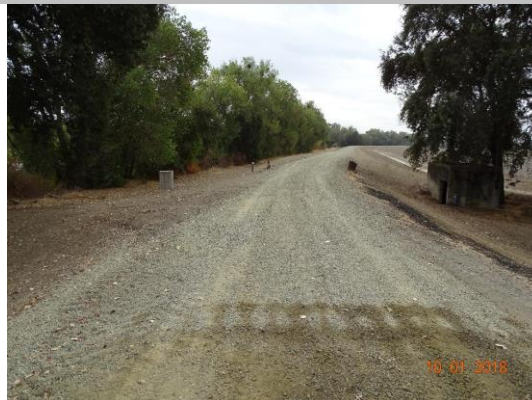
Photo 1 of 3 : UCIP_FA_2018_53048_78239.jpg

FIELD_STRUCT_DESC: 24-inch asphalt coated steel irrigation pipe through the levee, approximately 10 feet below the crown. Gate valve on the waterside (WS) shoulder. 1-1/4 inch conduit through the levee. Siphon breaker on the landside (LS) shoulder. Concrete distribution box and control box located on the LS. Pump, walkway, and gate located on the WS berm. (Permit No. 4213, 1973 - Scott Ranch) [Additional Reference(s): DWR Levee Log, 1992].
FS Date: 10/1/2018 1:24:05 PM

View of levee crown at crossing

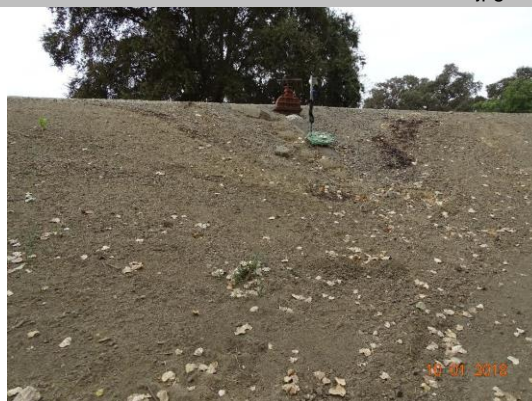
Photo 2 of 3 : UCIP_FA_2018_53048_78238.jpg

Comment Code						
Inspector Comment						
FS_ID:53048 DS_ID:16436 EP_NO: 4213 Repair Type: Urgent Crossing Status: Found UCIP Comments: 10/1/2018 Sinkhole near concrete structure on the LS was filled with soil and debris. Flow meter at the WS shoulder and a manometer on the pipe on the LS shoulder was installed. Video inspection is recommended to determine pipe integrity through levee. (O.Yakimov - DWR)5/3/2017 Sinkhole still present next to concrete structure on LS. (DWR Sutter Yard- AFreitag)10/24/2016 Pump is on WS. Sinkhole still present over pipe alignment next to the concrete building.(DWR Sutter Yard- AFreitag)4/25/2016 No repairs have been made since last inspection. Sink holes are still present above pipe next to concrete building on LS. (DWR Sutter Yard - afreitag)4/20/2015 Sink hole over pipe alignment on LS up against the concrete building. Need to dig up pipe and see if its leaking. (DWR Sutter Yard - afreitag)6/23/2014 Same as last inspection. (DWR Sutter Yard - afreitag)6/18/2014 Same as last inspection. (DWR Sutter Yard - afreitag)12/17/2013 Same as last inspection. (DWR Sutter Yard - afreitag)7/18/2013 Same as last inspection. (DWR Sutter Yard - afreitag)10/19/2012 Recommend adding door to LS concrete structure. Riser located on landward side is damaged. This crossing was listed in the USACE Periodic Inspection as ID# USACE_CESPK_MA1C_2010_p_0194 no issues logged. (DWR UCIP - omagana) FIELD_STRUCT_DESC: 24-inch asphalt coated steel irrigation pipe through the levee, approximately 10 feet below the crown. Gate valve on the waterside (WS) shoulder. 1-1/4 inch conduit through the levee. Siphon breaker on the landside (LS) shoulder. Concrete distribution box and control box located on the LS. Pump, walkway, and gate located on the WS berm. (Permit No. 4213, 1973 - Scott Ranch) [Additional Reference(s): DWR Levee Log, 1992]. FS Date: 10/1/2018 1:24:05 PM

Flow meter installed.

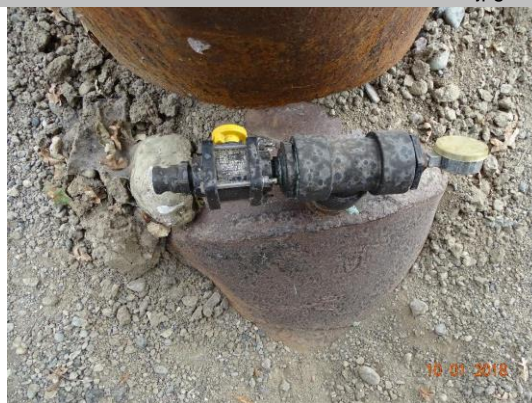
Photo 3 of 3 : UCIP_FA_2018_53048_78236.jpg

FIELD_STRUCT_DESC: 24-inch asphalt coated steel irrigation pipe through the levee, approximately 10 feet below the crown. Gate valve on the waterside (WS) shoulder. 1-1/4 inch conduit through the levee. Siphon breaker on the landside (LS) shoulder. Concrete distribution box and control box located on the LS. Pump, walkway, and gate located on the WS berm. (Permit No. 4213, 1973 - Scott Ranch) [Additional Reference(s): DWR Levee Log, 1992].
FS Date: 10/1/2018 1:24:05 PM

Manometer and air valve installed on pipe at LS shoulder.

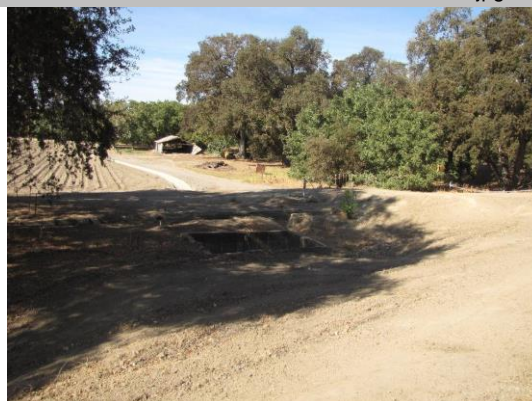
Photo 1 of 3 : UCIP_FA_2018_51861_70125.jpg

Concrete distribution box located on LS.

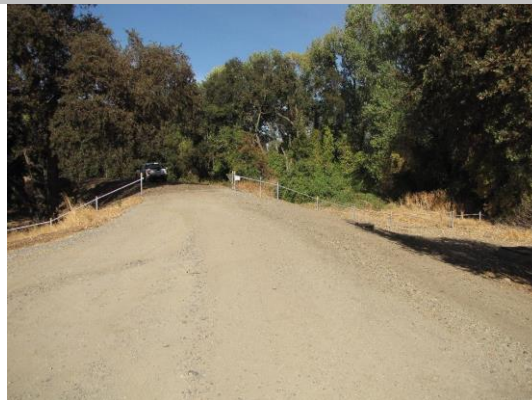
Photo 1 of 3 : UCIP_FA_2018_51862_70128.jpg

View of crossing looking upstream. Concrete box located on the WS.

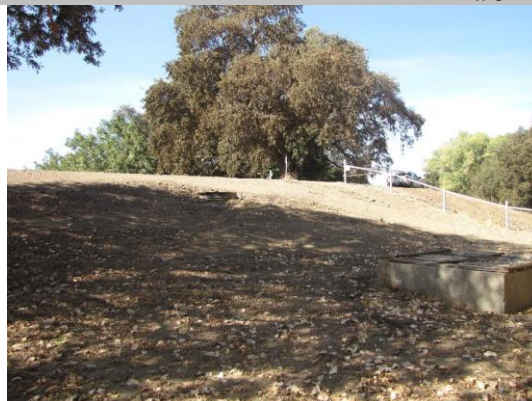
Photo 2 of 3 : UCIP_FA_2018_51862_70131.jpg

View of concrete distribution box and CMP riser located on WS.

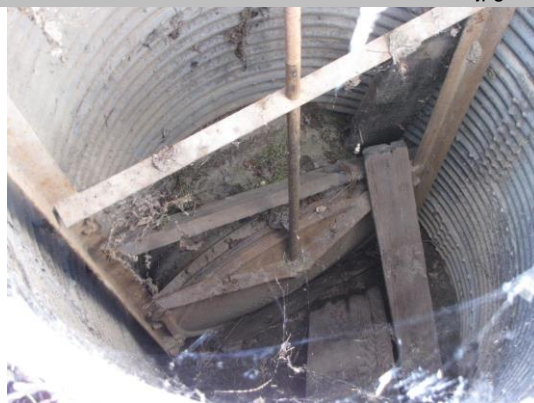
Photo 3 of 3 : UCIP_FA_2018_51862_70126.jpg

Comment Code						
Inspector Comment						
FS_ID:51862 DS_ID:16423 EP_NO: 9489 Repair Type: Non-Urgent Crossing Status: Found UCIP Comments: 5/3/2017 Appears abandoned- if so needs to be done properly. (DWR Sutter Yard- A Freitag)10/24/2016 Crossing appears abandoned.(DWR Sutter Yard- A Freitag)4/25/2016 Crossing appears abandoned and should be abandoned properly.4/20/2015 Same as last inspection.6/18/2014 Same as last inspection.12/17/2013 Same as last inspection.7/18/2013 Same as last inspection.10/19/2012 Slide gate wheel handle missing. Clear debris from CMP riser. This crossing was listed in the USACE Periodic Inspection as ID# USACE_CESPK_MA1C_2010_p_0196 for access box contains backfilled (permanently shut) and outlet located on landside has sediment build up. FIELD_STRUCT_DESC: 36-inch corrugated metal irrigation pipe through the levee at an unknown depth below the crown. Slide gate in corrugated metal pipe (CMP) riser on the waterside (WS) slope. 6-foot by 6-foot concrete box on the WS berm. Additional 12-inch pipe inside concrete distribution box. (Automatic Board Order (ABO) issued as Permit No. 9489, 1974 - Mayfair Farms Inc.) [Additional Reference(s): DWR Levee Log, 1992. USACE Sacramento O&M Manual 137, August 1955, (Station 198+00)]. FS Date: 5/19/2017 2:02:21 PM

WS-Inside view of CMP riser located on waterward slope.

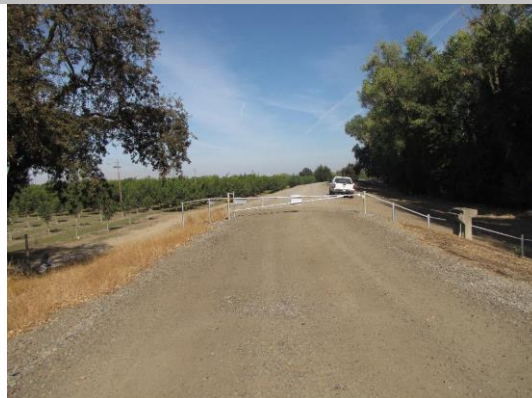
Photo 1 of 3 : UCIP_FA_2018_51864_70137.jpg

FS_ID:51864
DS_ID:16422
EP_NO: N/A
Repair Type: Non-Urgent
Crossing Status: Found
UCIP Comments: 5/3/2017 Appears abandoned- needs to be done so properly. (DWR Sutter Yard- A Freitag)10/24/2016 Appears to be abandoned.(DWR Sutter Yard- A Freitag)4/25/2016 Appears to be an abandoned crossing. 4/20/2015 Debris is still blocking gate. Appears to be an abandoned crossing.6/18/2014 Same as last inspection.12/17/2013 Same as last inspection.7/18/2013 Wheel to operate slide gate has been replaced but gate is still blocked by debris.10/19/2012 WS-wheel to operate slide gate missing, walkway has been removed; burrow activity near structure; debris in concrete distribution box WS blocking gate. This crossing was listed in the USACE Periodic Inspection as ID# USACE_CESPK_MA1C_2010_p_0207 the wheel to operate sluice gate missing.
FIELD_STRUCT_DESC: *ABANDONED* 24-inch drainage pipe of an unknown material through the levee, unknown depth below the crown. Walkway to slide gate on the waterside (WS) end. Walkway has been removed. Flap gate in concrete distribution box at the landside (LS) toe. [Additional Reference(s): DWR Levee Log, 1992].

View of levee crown looking upstream at crossing.

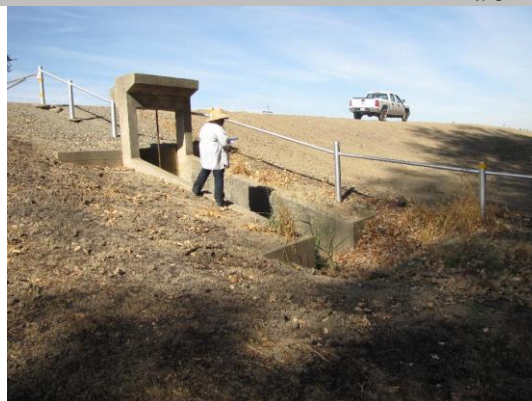
Photo 2 of 3 : UCIP_FA_2018_51864_70139.jpg

View of WS slope with concrete structure.

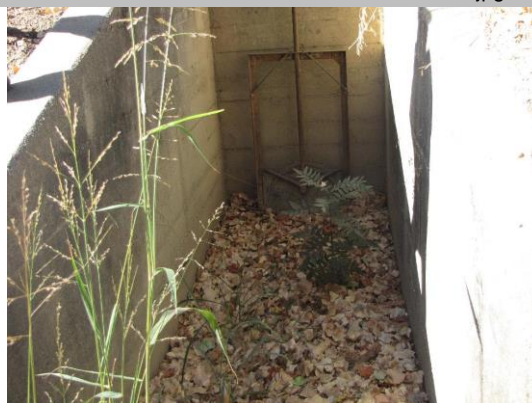
Photo 3 of 3 : UCIP_FA_2018_51864_70138.jpg

Comment Code						
Inspector Comment						
FS_ID:51864 DS_ID:16422 EP_NO: N/A Repair Type: Non-Urgent Crossing Status: Found UCIP Comments: 5/3/2017 Appears abandoned- needs to be done so properly. (DWR Sutter Yard- A Freitag)10/24/2016 Appears to be abandoned.(DWR Sutter Yard- A Freitag)4/25/2016 Appears to be an abandoned crossing. 4/20/2015 Debrs is still blocking gate. Appears to be an abandoned crossing.6/18/2014 Same as last inspection.12/17/2013 Same as last inspection.7/18/2013 Wheel to operate slide gate has been replaced but gate is still blocked by debris.10/19/2012 WS-wheel to operate slide gate missing, walkway has been removed; burrow activity near structure; debris in concrete distribution box WS blocking gate. This crossing was listed in the USACE Periodic Inspection as ID# USACE_CESPK_MA1C_2010_p_0207 the wheel to operate sluice gate missing. FIELD_STRUCT_DESC: *ABANDONED* 24-inch drainage pipe of an unknown material through the levee, unknown depth below the crown. Walkway to slide gate on the waterside (WS) end. Walkway has been removed. Flap gate in concrete distribution box at the landside (LS) toe. [Additional Reference(s): DWR Levee Log, 1992]. FS Date: 5/19/2017 2:05:36 PM

View of slide gate located on WS.

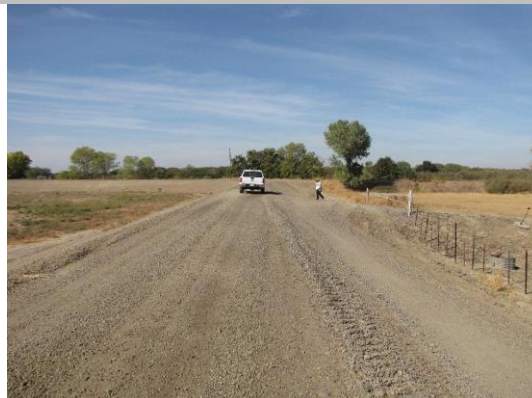
Photo 1 of 3 : UCIP_FA_2018_51865_70144.jpg

Comment Code						
Inspector Comment						
FS_ID:51865 DS_ID:16421 EP_NO: 9475 Repair Type: Non-Urgent Crossing Status: Found UCIP Comments: 5/3/2017 Abandoned- only WS standpipe visible. (DWR Sutter Yard- AFreitag)10/24/2016 Appears to be abandoned.(DWR Sutter Yard- AFreitag)4/25/2016 Abandoned crossing. Only WS standpipe is visible.4/20/2015 Same as last inspection.6/18/2014 Same as last inspection.12/17/2013 Same as last inspection.7/18/2013 Same as last inspection.10/19/2012 Burrow activity; limited visibility of this crossing only on WS riser. This crossing was listed in the USACE Periodic Inspection as ID# USACE_CESPK_MA1C_2010_p_0207 the wheel to operate sluice gate missing. Issue addressed wheel to slide gate has been installed. FIELD_STRUCT_DESC: *ABANDONED* 30-inch corrugated metal irrigation pipe through the levee, 16.1 feet below the crown. Slide gate inside corrugated metal pipe (CMP) riser located on the waterside (WS) end. Line buried on the WS and landside (LS). (Automatic Board Order (ABO) issued as Permit No. 9475, 1974 - Mattie B. Zumwalt Co.) [Additional Reference(s): DWR Levee Log, 1992. USACE Sacramento O&M Manual 137, August 1955, (Station 247+86)]. FS Date: 5/23/2017 9:39:55 AM

Overview of levee crown looking upstream at crossing.

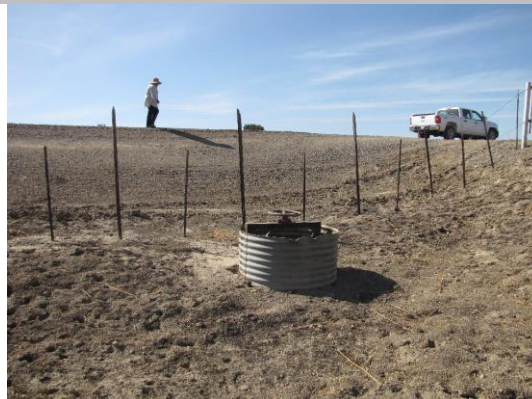
Photo 2 of 3 : UCIP_FA_2018_51865_70147.jpg

Riser with slide gate located on WS toe.

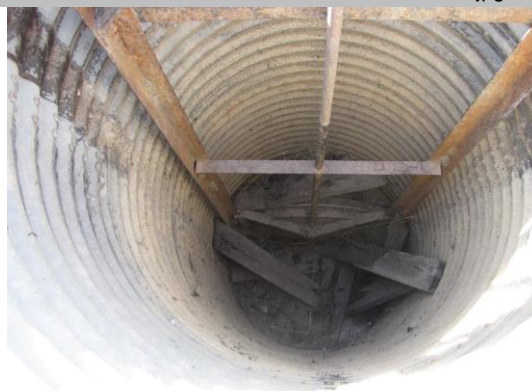
Photo 3 of 3 : UCIP_FA_2018_51865_70146.jpg

Comment Code						
Inspector Comment						
FS_ID:51865 DS_ID:16421 EP_NO: 9475 Repair Type: Non-Urgent Crossing Status: Found UCIP Comments: 5/3/2017 Abandoned- only WS standpipe visible. (DWR Sutter Yard- AFreitag)10/24/2016 Appears to be abandoned.(DWR Sutter Yard- AFreitag)4/25/2016 Abandoned crossing. Only WS standpipe is visible.4/20/2015 Same as last inspection.6/18/2014 Same as last inspection.12/17/2013 Same as last inspection.7/18/2013 Same as last inspection.10/19/2012 Burrow activity; limited visibility of this crossing only on WS riser. This crossing was listed in the USACE Periodic Inspection as ID# USACE_CESPK_MA1C_2010_p_0207 the wheel to operate sluice gate missing. Issue addressed wheel to slide gate has been installed. FIELD_STRUCT_DESC: *ABANDONED* 30-inch corrugated metal irrigation pipe through the levee, 16.1 feet below the crown. Slide gate inside corrugated metal pipe (CMP) riser located on the waterside (WS) end. Line buried on the WS and landside (LS). (Automatic Board Order (ABO) issued as Permit No. 9475, 1974 - Mattie B. Zumwalt Co.) [Additional Reference(s): DWR Levee Log, 1992. USACE Sacramento O&M Manual 137, August 1955, (Station 247+86)]. FS Date: 5/23/2017 9:39:55 AM

WS--Woody debris inside riser blocking gate.

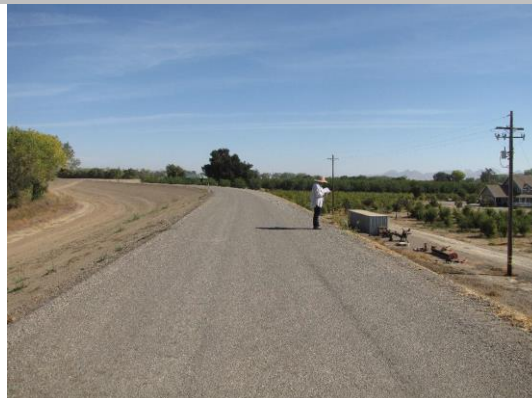
Photo 1 of 3 : UCIP_FA_2018_51868_70150.jpg

FS_ID:51868
DS_ID:16420
EP_NO: 4903
Repair Type: Non-Urgent
Crossing Status: Indicator Found
UCIP Comments: 5/3/2017 Appears abandoned- if so needs to be done properly. (DWR Sutter Yard- A Freitag)10/24/2016 appears to be abandoned.(DWR Sutter Yard- A Freitag)4/25/2016 Appears to be an abandoned crossing.4/20/2015 Suspect that pump on LS is a well pump and has nothing to do with this crossing.6/18/2014 Same as last inspection.12/17/2013 Same as last inspection.7/18/2013 Same as last inspection.10/19/2012 Unable to locate siphon breaker, pump on LS; unable to tell if pump system is part of appurtenances. This crossing was listed in the USACE Periodic Inspection as ID# USACE_CESPK_MA1C_2010_p_0233 for utility pole and 8 inch steel riser located on landward toe.
FIELD_STRUCT_DESC: 12-inch asphalt coated steel irrigation pipe through the levee, approximately 18-20 feet below the crown. Siphon breaker in 24-inch corrugated metal pipe (CMP) riser on the landside (LS) shoulder--not found. 3-inch electrical conduit through the levee--not found. Utility pole visible on the LS. Well station visible on the LS. No appurtenances visible on the waterside (WS). (Permit No. 4903, 4903-A, 1966 - Mattie B. Zumwalt Company, Inc.) [Additional Reference(s): DWR Levee Log, 1992].

View of levee crown looking downstream at crossing.

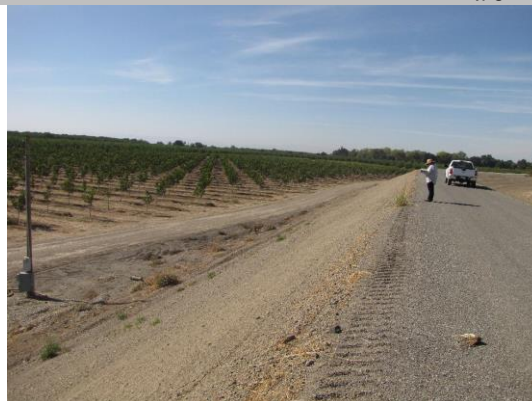
Photo 2 of 3 : UCIP_FA_2018_51868_70149.jpg

View of levee crown looking upstream at crossing.

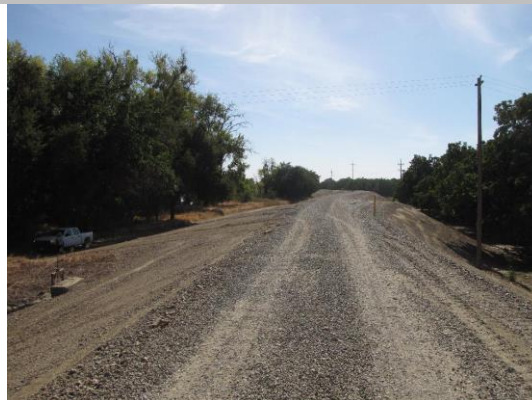
Photo 1 of 3 : UCIP_FA_2018_51869_70154.jpg

FS_ID:51869
DS_ID:16419
EP_NO: 9476
Repair Type: Non-Urgent
Crossing Status: Found
UCIP Comments: 5/3/2017 Culvert has sediment build up in it- needs to be cleaned out. (DWR Sutter Yard- A Freitag)10/24/2016 LS outlets becoming over grown with vegetation in the ditch.(DWR Sutter Yard- A Freitag)4/25/2016 WS entry still blocked and wingwalls still cracked.4/20/2015 WS entry still blocked and wingwalls still cracked.6/18/2014 Same as last inspection.12/17/2013 Same as last inspection.7/18/2013 Same as last inspection.10/19/2012 blocked, no entry on WS. This crossing was listed in the USACE Periodic Inspection as ID# USACE_CESPK_MA1C_2010_p_0247 for u/s and d/s wing wall shows some cracking and tilting.
FIELD_STRUCT_DESC: 1 of 2: 36-inch corrugated metal irrigation pipe and concrete box culvert through the levee at an unknown depth below the crown. Concrete headwall visible on the landside (LS) toe.

Overview of levee crown looking downstream at crossing.

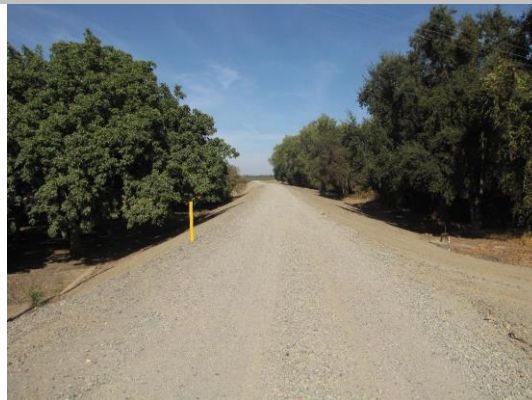
Photo 2 of 3 : UCIP_FA_2018_51869_70152.jpg

View of crossing looking upstream at crossing.

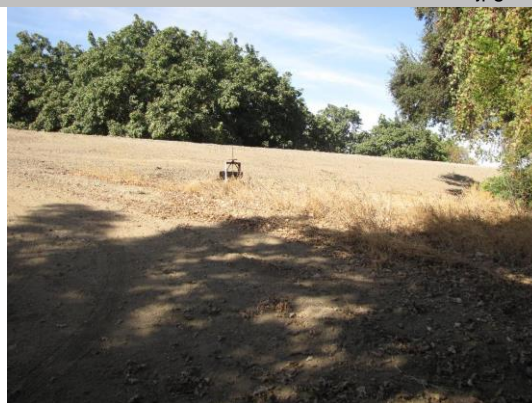
Photo 3 of 3 : UCIP_FA_2018_51869_70156.jpg

Comment Code						
Inspector Comment						
FS_ID:51869 DS_ID:16419 EP_NO: 9476 Repair Type: Non-Urgent Crossing Status: Found UCIP Comments: 5/3/2017 Culvert has sediment build up in it- needs to be cleaned out. (DWR Sutter Yard- AFreitag)10/24/2016 LS outlets becoming over grown with vegetation in the ditch.(DWR Sutter Yard- AFreitag)4/25/2016 WS entry still blocked and wingwalls still cracked.4/20/2015 WS entry still blocked and wingwalls still cracked.6/18/2014 Same as last inspection.12/17/2013 Same as last inspection.7/18/2013 Same as last inspection.10/19/2012 blocked, no entry on WS. This crossing was listed in the USACE Periodic Inspection as ID# USACE_CESPK_MA1C_2010_p_0247 for u/s and d/s wing wall shows some cracking and tilting. FIELD_STRUCT_DESC: 1 of 2: 36-inch corrugated metal irrigation pipe and concrete box culvert through the levee at an unknown depth below the crown. Concrete headwall visible on the landside (LS) toe. (Automatic Board Order (ABO) issued as Permit No. 9476, 1974 - Ohliger) [Additional Reference(s): DWR Levee Log, 1992]. FS Date: 5/23/2017 9:51:10 AM

View of WS slope and access road. Slide gate is second crossing at this location.

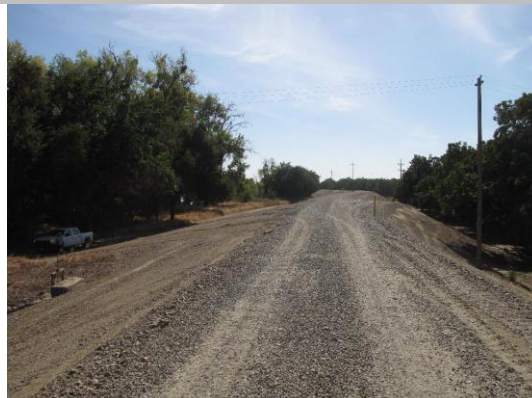
Photo 1 of 3 : UCIP_FA_2018_51870_70162.jpg

Comment Code					
Inspector Comment					
FS_ID:51870 DS_ID:17569 EP_NO: 9476 Repair Type: Non-Urgent Crossing Status: Found UCIP Comments: 5/3/2107 Culvert has sediment build up in it- needs to be cleaned out. (DWR Sutter Yard- A Freitag)10/24/2016 LS outlets becoming overgrown with vegetation in the dtch.(DWR Sutter Yard- A Freitag)4/25/2016 WS entry still blocked and wingwalls still cracked.4/20/2015 WS entry still blocked and wingwalls still cracked.6/18/2014 Same as last inspection.12/17/2013 Same as last inspection.7/18/2013 Same as last inspection.10/19/2012 blocked, no entry on WS. This crossing was listed in the USACE Periodic Inspection as ID# USACE_CESPK_MA1C_2010_p_0247 for u/s and d/s wing wall shows some cracking and tilting. FIELD_STRUCT_DESC: 2 of 2: 36-inch corrugated metal irrigation pipe (15 feet long) and concrete box culvert through the levee at an unknown depth below the crown. Slide gate located on the waterside (WS). Concrete headwall visible on the landside (LS) toe. (Automatic Board Order (ABO) issued as Permit No. 9476-1974, Howard C. & Nadine M. Ohliger) [Additional Reference(s): DWR Levee Log, 1992]. FS Date: 5/23/2017 9:56:33 AM

View of levee crown looking downstream at crossing.

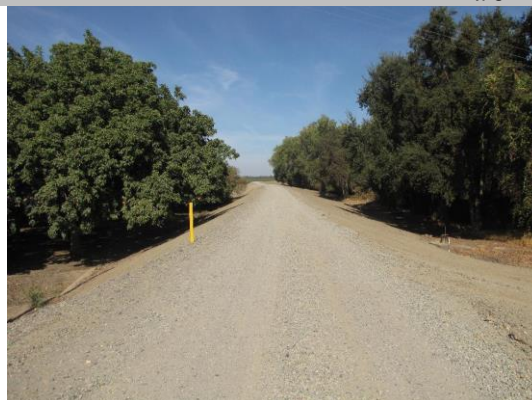
Photo 2 of 3 : UCIP_FA_2018_51870_70161.jpg

View of levee crown looking upstream at crossing.

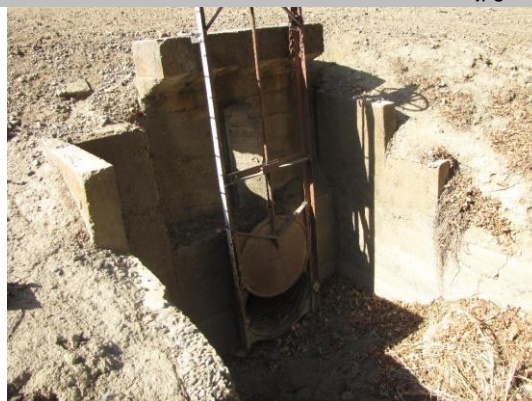
Photo 3 of 3 : UCIP_FA_2018_51870_70160.jpg

Comment Code						
Inspector Comment						
FS_ID:51870 DS_ID:17569 EP_NO: 9476 Repair Type: Non-Urgent Crossing Status: Found UCIP Comments: 5/3/2107 Culvert has sediment build up in it- needs to be cleaned out. (DWR Sutter Yard- A Freitag)10/24/2016 LS outlets becoming overgrown with vegetation in the dtch.(DWR Sutter Yard- A Freitag)4/25/2016 WS entry still blocked and wingwalls still cracked.4/20/2015 WS entry still blocked and wingwalls still cracked.6/18/2014 Same as last inspection.12/17/2013 Same as last inspection.7/18/2013 Same as last inspection.10/19/2012 blocked, no entry on WS. This crossing was listed in the USACE Periodic Inspection as ID# USACE_CESPK_MA1C_2010_p_0247 for u/s and d/s wing wall shows some cracking and tilting. FIELD_STRUCT_DESC: 2 of 2: 36-inch corrugated metal irrigation pipe (15 feet long) and concrete box culvert through the levee at an unknown depth below the crown. Slide gate located on the waterside (WS). Concrete headwall visible on the landside (LS) toe. (Automatic Board Order (ABO) issued as Permit No. 9476-1974, Howard C. & Nadine M. Ohliger) [Additional Reference(s): DWR Levee Log, 1992]. FS Date: 5/23/2017 9:56:33 AM

Headwall and slide gate located on WS.

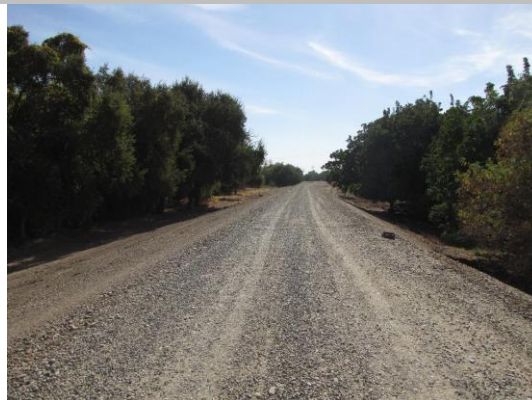
Photo 1 of 3 : UCIP_FA_2018_51872_70167.jpg

FS_ID:51872
DS_ID:16418
EP_NO: 6263
Repair Type: Non-Urgent
Crossing Status: Found
UCIP Comments: 5/3/2017 Crossing appears to be in good condition.
(DWR Sutter Yard- A Freitag)10/24/2016 Appears to be in good condition.
(DWR Sutter Yard- A Freitag)4/25/2016 Pressure gauge and valve were added to pipe near the siphon breaker on LS shoulder.
4/20/2015 Modifications are being made to pipe near the LS shoulder. Not sure what all exactly is being done.
6/23/2014 Same as last inspection. 12/17/2013 Same as last inspection. 7/18/2013 Debris cleared from in front of LS standpipe.
10/19/2012 Remove debris from landward side see photo 2. This crossing was listed in the USACE Periodic Inspection as ID# USACE_CESPK_MA1C_2010_p_0249 however, unable to determine why crossing was marked "U".
FIELD_STRUCT_DESC: 18-inch asphalt coated steel irrigation pipe through the levee, 2 feet below the crown. Siphon breaker on the landside (LS) shoulder. Corrugated metal pipe (CMP) riser located on the LS connects with concrete V-ditch. Dual slant pumps and gate valves on the bank approximately 215 feet from waterside (WS) toe. Pump feeds into single 18-inch steel pipe. 2-inch electrical conduit buried in the same trench as the irrigation pipe. (Permit No. 6263, 1968 - C. Tuttle) [Additional Reference(s): DWR Levee Log, 1992].

Overview of levee crown looking downstream at crossing.

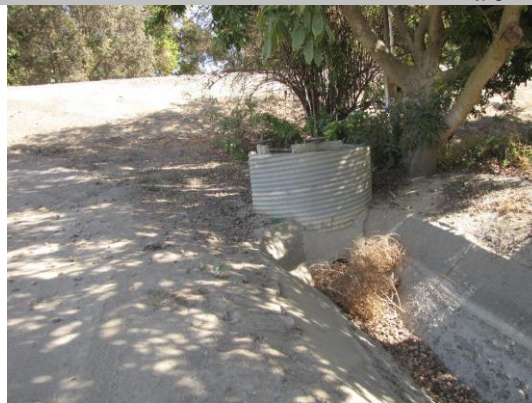
Photo 2 of 3 : UCIP_FA_2018_51872_70166.jpg

CMP riser and concrete lined v-ditch located on LS toe.

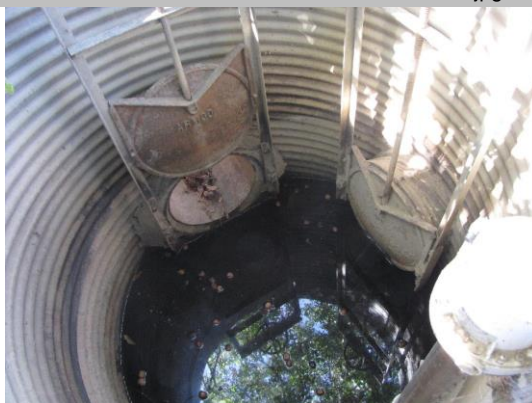
Photo 3 of 3 : UCIP_FA_2018_51872_70171.jpg

Comment Code						
Inspector Comment						
FS_ID:51872 DS_ID:16418 EP_NO: 6263 Repair Type: Non-Urgent Crossing Status: Found UCIP Comments: 5/3/2017 Crossing appears to be in good condition. (DWR Sutter Yard- AFreitag)10/24/2016 Appears to be in good condition.(DWR Sutter Yard- AFreitag)4/25/2016 Pressure gauge and valve were added to pipe near the siphon breaker on LS shoulder.4/20/2015 Modifications are being made to pipe near the LS shoulder. Not sure what all exactly is being done.6/23/2014 Same as last inspection. 12/17/2013 Same as last inspection.7/18/2013 Debris cleared from in front of LS standpipe.10/19/2012 Remove debris from landward side see photo 2. This crossing was listed in the USACE Periodic Inspection as ID# USACE_CESPK_MA1C_2010_p_0249 however, unable to determine why crossing was marked "U". FIELD_STRUCT_DESC: 18-inch asphalt coated steel irrigation pipe through the levee, 2 feet below the crown. Siphon breaker on the landside (LS) shoulder. Corrugated metal pipe (CMP) riser located on the LS connects with concrete V-ditch. Dual slant pumps and gate valves on the bank approximately 215 feet from waterside (WS) toe. Pump feeds into single 18-inch steel pipe. 2-inch electrical conduit buried in the same trench as the irrigation pipe. (Permit No. 6263, 1968 - C. Tuttle) [Additional Reference(s): DWR Levee Log, 1992]. FS Date: 5/23/2017 10:05:22 AM

Photo 1 of 2 inside view of CMP riser located on LS toe.

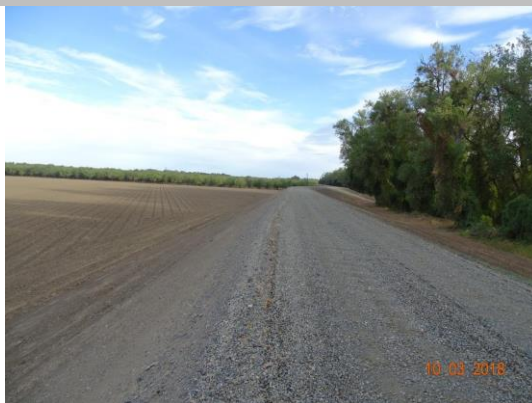
Photo 1 of 1 : FA_2018_MA0001_297_70_20181005_00151.jpg

LM Start	5.97	Rating **	A	Issue No.	70
LM End	5.97	Issue Type +	Ma	Location *	LS
Category	Earthen Levee			GPS Latitude/Longitude	
				Start	End
Item	Vegetation			39.275672 °	39.275672 °
				-122.023570 °	-122.023570 °
DWR ID	DWR_MA0001_01_f_2018_70				
Comment Code					
V1 : Control annual grass and weeds on the levee slopes and easements.					
Inspector Comment					
The LMA is doing an excellent job of managing the vegetation on the slopes of the levee in this area.

View of the levee with no vegetation on both slopes.

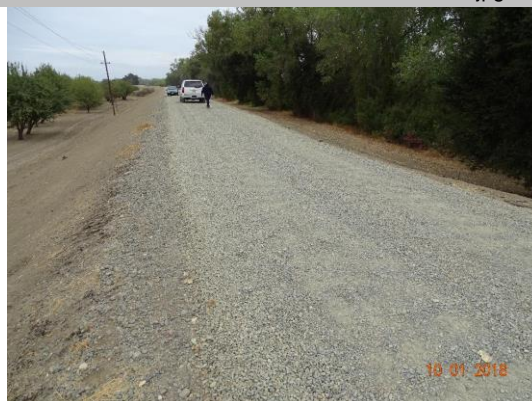
Photo 1 of 3 : UCIP_FA_2018_53049_78240.jpg

UCIP Comments: 10/1/2018 PVC pipe underneath the slide gate that is located inside CMP riser on WS shoulder was restored and blocks gate from closing. Sediment built up at the bottom of CMP riser. PVC pipe needs to be removed in order to properly close slide gate. (O.Yakimov - DWR)5/3/2017 Pipe leaked during the Jan/Feb 2017 high water event. Sand bags were placed at both the LS and WS outlets as well as down inside the standpipe to slow the water flow. The 5inch pvc was cut away but the slide gate could still not close fully. Suspect sediment build up was in the bottom of the stand pipe was blocking the gate. Inside of pipe should be cleaned out. (DWR Sutter Yard - AFreitag)10/24/2016 Pvc was back running through the crossing and blocking the screwgate. photo attached(DWR Sutter Yard - AFreitag)9/28/2016 Crossing has been downgraded from Urgent to Non-Urgent 5-inch PVC pipe was cut to allow the slide gate to close. Need to contact owner to remove unauthorized pipe to comply with Title 23. (DWR UCIP - omagana)4/25/2016 5 inch pvc pipe running through crossing has been cut out to allow the slide gate to close. (DWR Sutter Yard - afreitag)4/20/2015 5inch pvc is still present blocking slide gate from closing. WS end of pipe has been exposed so there is no way to stop water from flowing through pipe during highwater times. (DWR Sutter Yard - afreitag)6/23/2014 Same as last inspection. There is no way to stop water from flowing through pipe during high water times. (DWR Sutter Yard - afreitag)12/17/2013 Same as last inspection. (DWR Sutter Yard - afreitag)7/18/2013 Same as last inspection. (DWR Sutter Yard - afreitag)10/19/2012 Unauthorized 5 inch PVC pipe running through 36 inch crossing. 5 inch PVC crossing prevents slide gate from closing during high water. Debris and sediment inside riser. This crossing was listed in the USACE Periodic Inspection as ID# USACE_CESPK_MA1C_2010_p_0258 for 5 inch PVC pipe running through culvert. (DWR UCIP - omagana) FIELD_STRUCT_DESC: 36-inch steel (not corrugated metal, as referenced in O&M manual) drainage pipe through the levee, approximately 14-16 feet below levee crown. Slide gate in corrugated metal pipe (CMP) riser on the waterside (WS) slope. Pipe also visible on the landside (LS). [Additional Reference(s): DWR Levee Log, 1992. USACE Sacramento O&M Manual 137, August 1955, (Station 331+31)]. FS Date: 10/1/2018 2:59:44 PM

View of levee crown at crossing.

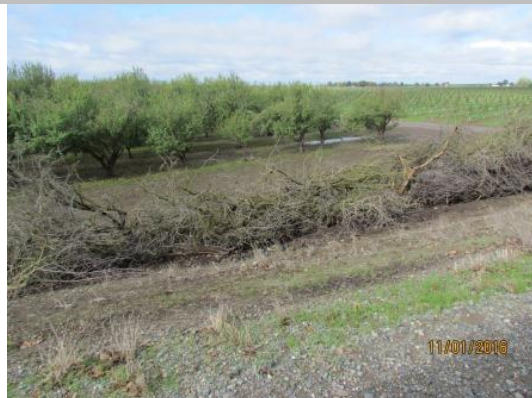
Photo 1 of 1 : FA_2018_MA0001_297_115_20180905_00035.jpg

LM Start	6.38	Rating **	M	Issue No.	115
LM End	6.38	Issue Type +	En	Location *	LS
Category	Earthen Levee			GPS Latitude/Longitude	
				Start	End
Item	Encroachments			39.281425 °	39.281425 °
				-122.022000 °	-122.022000 °
DWR ID	DWR_MA0001_01_f_2016_115				
Comment Code					
PR : Prunings					
Inspector Comment					
Remove prunings from the landside toe.

View of the prunings along the landside toe.

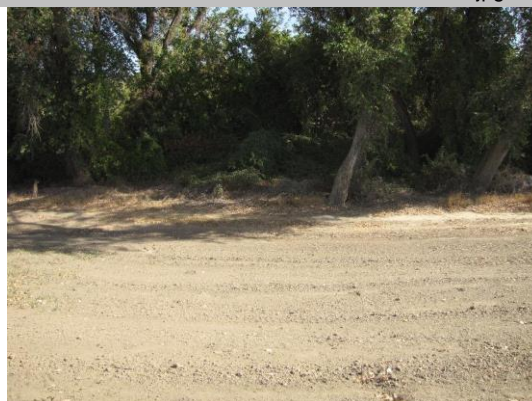
Photo 1 of 3 : UCIP_FA_2018_51874_70181.jpg

Comment Code					
Inspector Comment					
FS_ID:51874 DS_ID:16425 EP_NO: N/A Repair Type: Non-Urgent Crossing Status: Found UCIP Comments: 5/3/2017 Abandoned- needs to be done properly. (DWR Sutter Yard- A Freitag)10/24/2016 Abandoned(DWR Sutter Yard- A Freitag)4/25/2016 Abandoned crossing.4/20/2015 Same as last inspection.6/23/2014 Same as last inspection.12/17/2013 Same as last inspection.7/18/2013 Same as last inspection.10/19/2012 Need to be properly abandoned concrete structure; plate covers concrete box; Concrete headwall damaged. This crossing was listed in the USACE Periodic Inspection as ID# USACE_CESPK_MA1C_2010_p_0262 for damage to concrete structure (vertical 2 inch wide cracks and spalling visible). FIELD_STRUCT_DESC: *ABANDONED* 72-inch corrugated metal (precast concrete) drainage pipe through the levee at an unknown depth below the crown. Structure is blocked on the waterside (WS) end with 3-foot concrete plug installed in 1980. Slide gate in concrete well on the landside (LS) shoulder. Concrete headwall at both toes. WS headwall not found. [Additional Reference(s): DWR Levee Log, 1992. USACE Sacramento O&M Manual 137, August 1955, (Station 339+74)]. FS Date: 5/23/2017 10:13:24 AM

View of WS no structure features visible.

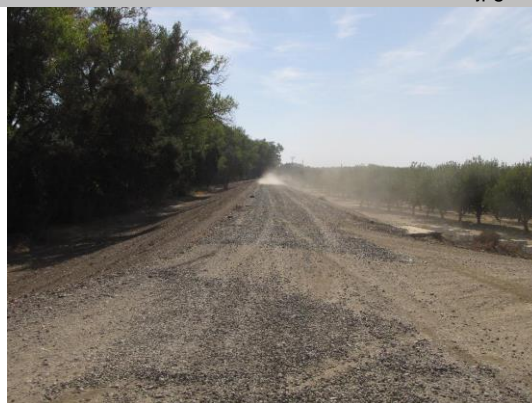
Photo 2 of 3 : UCIP_FA_2018_51874_70180.jpg

Comment Code						
Inspector Comment						
FS_ID:51874 DS_ID:16425 EP_NO: N/A Repair Type: Non-Urgent Crossing Status: Found UCIP Comments: 5/3/2017 Abandoned- needs to be done properly. (DWR Sutter Yard- A Freitag)10/24/2016 Abandoned(DWR Sutter Yard- A Freitag)4/25/2016 Abandoned crossing.4/20/2015 Same as last inspection.6/23/2014 Same as last inspection.12/17/2013 Same as last inspection.7/18/2013 Same as last inspection.10/19/2012 Need to be properly abandoned concrete structure; plate covers concrete box; Concrete headwall damaged. This crossing was listed in the USACE Periodic Inspection as ID# USACE_CESPK_MA1C_2010_p_0262 for damage to concrete structure (vertical 2 inch wide cracks and spalling visible). FIELD_STRUCT_DESC: *ABANDONED* 72-inch corrugated metal (precast concrete) drainage pipe through the levee at an unknown depth below the crown. Structure is blocked on the waterside (WS) end with 3-foot concrete plug installed in 1980. Slide gate in concrete well on the landside (LS) shoulder. Concrete headwall at both toes. WS headwall not found. [Additional Reference(s): DWR Levee Log, 1992. USACE Sacramento O&M Manual 137, August 1955, (Station 339+74)]. FS Date: 5/23/2017 10:13:24 AM

Overview of levee crown looking downstream at crossing.

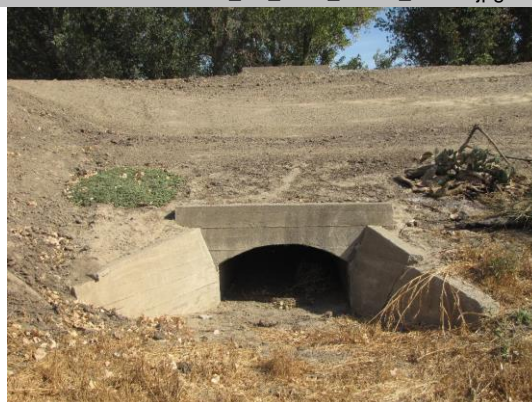
Photo 3 of 3 : UCIP_FA_2018_51874_70179.jpg

View of structure located in LS.

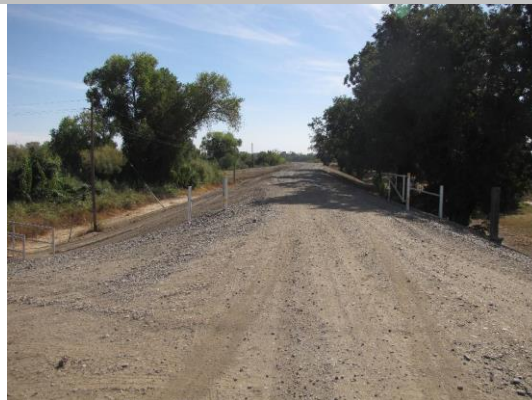
Photo 1 of 3 : UCIP_FA_2018_51875_70188.jpg

FS_ID:51875
DS_ID:16427
EP_NO: 9482
Repair Type: Non-Urgent
Crossing Status: Found
UCIP Comments: 5/3/2017 Abandoned- Needs to be done properly.
(DWR Sutter Yard- A Freitag)10/24/2016 Abandoned.(DWR Sutter Yard- A Freitag)4/25/2016 Abandoned pipe. Needs to be properly plugged if it never gets used.4/20/2015 Same as last inspection. Structure is still buried.6/23/2014 Same as last inspection.12/17/2013 Same as last inspection.7/18/2013 Same as last inspection.10/19/2012 Structure is buried and non-operational. This crossing was listed in the USACE Periodic Inspection as ID# USACE_CESPK_MA1C_2010_p_0288 for sluice gate closed and backfilled on WS and full of sediment with wingwall cracked on LS. FIELD_STRUCT_DESC: *ABANDONED* 1 of 2: 36-inch reinforced concrete irrigation pipe through the levee at approximately 18 feet below the crown. Wooden slide gates on the waterside (WS) end. Sliding metal gate noted in O&M manual. Concrete headwalls located on both WS and landside (LS). O&M manual structure reference is 4'-9" x 9'-6" concrete box culvert. (Automatic Board Order (ABO) issued as Permit No. 9482, 1974 - Elizabeth M. Farnsworth) [Additional Reference(s): DWR Levee Log, 1992. USACE Sacramento O&M Manual 137, August 1955, (Station 370+90)].

Overview of levee crown looking downstream at crossing.

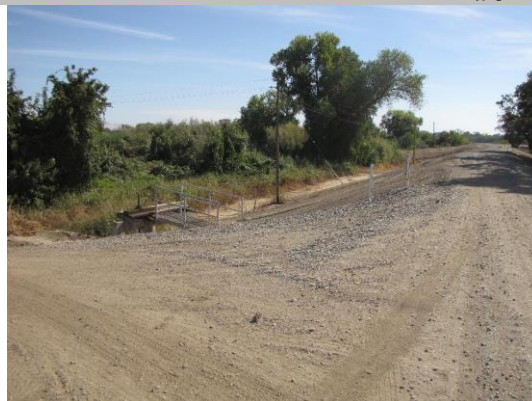
Photo 2 of 3 : UCIP_FA_2018_51875_70187.jpg

WS-walkway and concrete headwall.
